SEA FLOOR TECHNOLOGY
REPORT No. 2

ORB - RUM OPERATIONS
MARCH THROUGH AUGUST 1970

Victor C. Anderson
Daniel K. Gibson

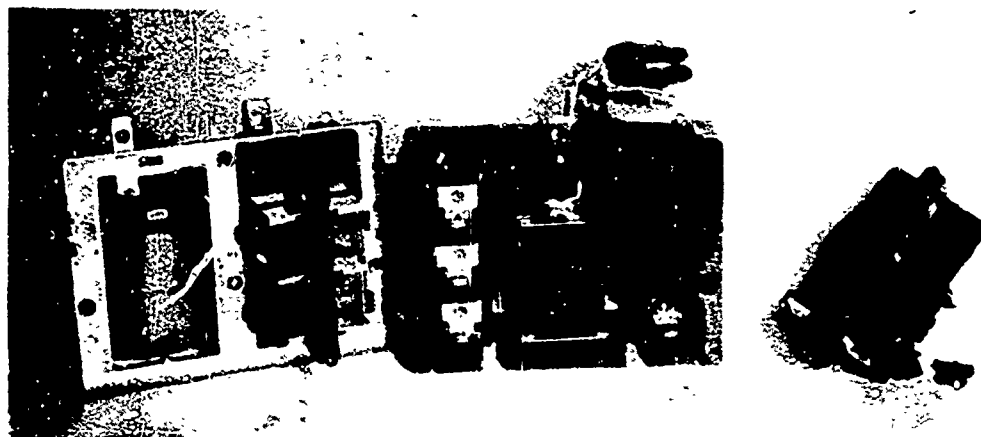
vehicle. Extensive carbon formation can be seen extruding out around the terminals at the top of the contact enclosure. Figure 7 shows the interior of the disassembled contactor with some of the contacts burned completely away.

Fig. 7. Extensive carbon formation and severely burned contacts inside contactor.

Upon return to port, a careful inspection revealed that all power control contactor failures, which had occurred during this last deep test of the vehicle, were associated with a particular type of contactor. These were found to have badly burned contacts and extensive carbon deposit build-up in the contact area, even to the point of actually bridging across the contacts in some cases. All contactors of this type used for power control were replaced by another type having larger contacts and wider contact spacing. The type used for replacement was selected strictly on the basis that several had already seen limited service in the vehicle without failure up to this date.

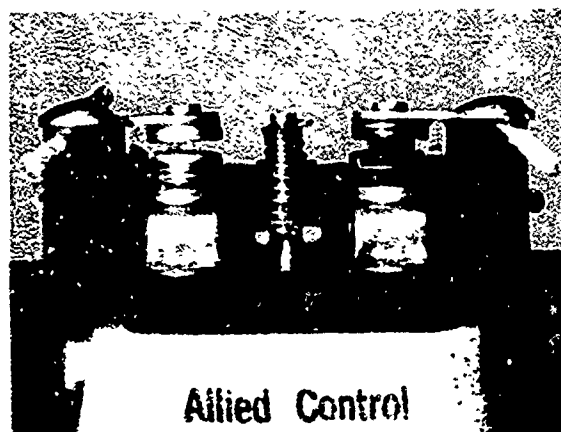
In the photo of Figure 9, a test relay is shown. Both sets of contacts were wired to identical 4 A inductive loads. The power supply was 120 V 60 Hz. The test was conducted at 2000 psi. The unsquelched set of contacts on the right failed during the first 5 make-break cycles, so power was removed from this pair only. The other (SCR squelched) pair of contacts on the left are in perfect condition after more than 2000 make-break cycles under load.

Fig. 9. Test relay contacts.
